# Concrete Sewer Pipe Corrosion Induced by Sulphuric Acid Environment

Anna Romanova, Mojtaba Mahmoodian, Upul Chandrasekara, Morteza A. Alani

**Keywords**—Sewer pipes, concrete corrosion, sulphuric acid, concrete coupons, corrosion rate.

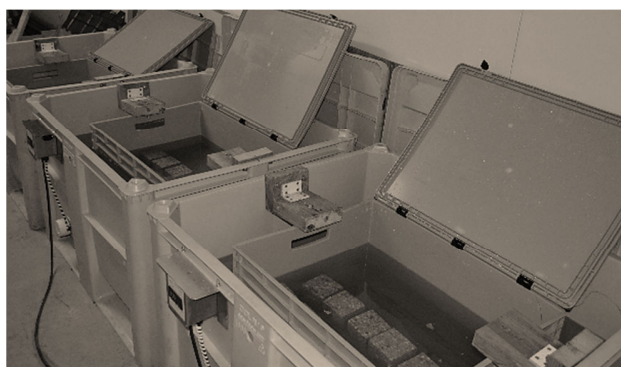
Fig. 1 Experimental set up of cubes being submerged into diluted sulphuric acid

The chamber hosted three 500L HDPE tanks where two of them were curing tanks and could autonomously control the fluid temperature inside them. Each of the tanks had a further 120L HDPE container, which was submerged by 2/3 into the fluid contained by 500L tank. This was done to create a thermal bath type effect and control a constant temperature of the solution in 120L containers. To avoid any fluctuation or displacement of the containers they were attached to the sides of the tanks by the use of L-type brackets. Three tanks: Tank 1, Tank 2 and Tank 3 maintained a constant temperature of solution located in containers of 10°C, 20°C and 30°C, respectively. The temperatures were chosen to represent the common range of effluent temperatures found in sewer pipes at different climate conditions. The temperature of Tank 1 was controlled by the environmental chamber which was set to deliver 10°C at a humidity level of 70%. Tank 2 and 3 temperatures were controlled autonomously by heating elements.

A total number of 45 cubes, cut out from brand-new circular concrete pipe were used in these experiments. Each cube had a measurement of 100x100x100mm and was cut with diamond-blade rotating saw, however as the process of cutting a circular pipe is very challenging and labour consuming a tolerance of 10% in each side measurement of the cube was allowed for. A number of 15 cubes were fully submerged into 0.5 pH solution of sulphuric acid in each of the containers in Tanks 1, 2 and 3. Further they were extracted at different points in time and assessed using different techniques to account for the corrosion level. Fig. 1 demonstrates a setup of tanks, containers and cubes located in the environmental chamber.

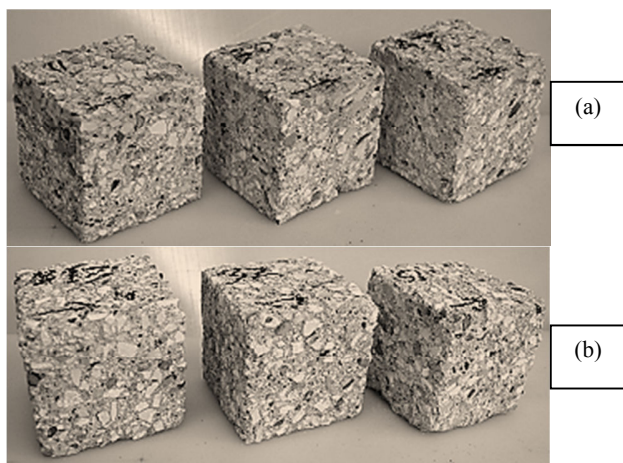
Fig. 5 Cube samples 11, 30 and 47 (left to right) after 42 days immersion into 0.5 pH sulphuric acid solution and temperatures of 10°C, 20°C and 30°C, respectively (a) and cube samples 13, 32 and 51 (left to right) after 56 days immersion into 0.5 pH sulphuric acid solution and temperatures of 10°C, 20°C and 30°C, respectively (b)

Interestingly that the leap between the cubes corrosion depth doubled in periods from 28 days to 42 days and then further between 42 days to 56 days which could be visibly assessed. Examples of such can we seen in Fig. 5.
