Deformation Characteristics of Fire Damaged and Rehabilitated Normal Strength Concrete Beams

Keywords—Fire, Normal strength concrete, Rehabilitation, Reinforced concrete beam

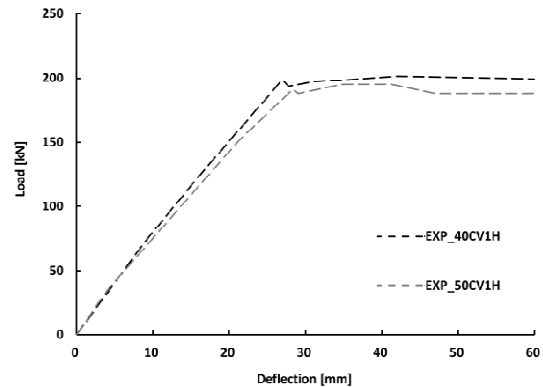
Fig. 9 Load-deflection curves of test specimens heated for 1 hour

Fig. 9 illustrates load-deflection curves of RC beam specimens having cover thickness with 40mm and 50mm heated for 1 hour. As shown, maximum load and slope of 40CV1H specimen are higher than those of 50CV1H specimen because 40CV1H has lower temperature distributions and larger beam depth compared to 50CV1H. The same tendencies are also shown in the load-deflection curves from results of RC beams heated for 2 hours as illustrated in Fig. 10.

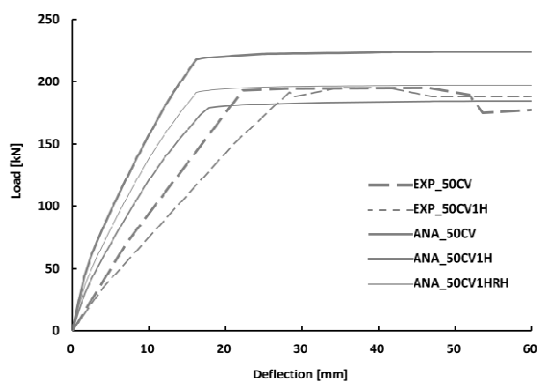
Fig. 17 Load-deflection curves from experiment and analysis of RC beams having cover thickness 50mm

The rehabilitation effects can be illustrated in Figs. 15~17. Comparing Figs. 15 (a) and (b), rehabilitated beam model, 40CV1HRH, has larger maximum principal stress than fire damaged beam model, 40CV1H. As seen in Figs. 16 and 17, analytical and experimental results are in good agreements.
