Triplet Shear Tests on Retrofitted Brickwork Masonry Walls

Berna Istegun, Erkan Celebi

Abstract—The main objective of this experimental study is to assess the shear strength and the crack behavior of the triplets built of perforated brickwork masonry elements. In order to observe the influence of shear resistance and energy dissipating before and after retrofitting applications by using the reinforcing system, static-cyclic shear tests were employed in the structural mechanics laboratory of Sakarya University. The reinforcing system is composed of hybrid multiaxial seismic fabric consisting of alkali resistant glass and polypropylene fibers. The plaster as bonding material used in the specimen's retrofitting consists of expanded glass granular. In order to acquire exact measuring data about the failure behavior of the two mortar joints under shear stressing, vertical load-controlled cylinder having force capacity of 50 kN and loading rate of 1.5 mm/min. with an internal inductive displacement transducers is carried out perpendicular to the triplet specimens. In this study, a total of six triplet specimens with textile reinforcement were prepared for these shear bond tests. The th

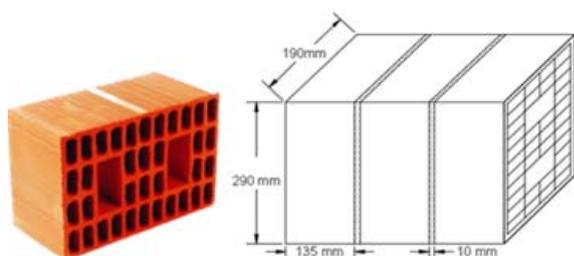
Fig. 1 Brick block and triplet specimen

Technical features of perforated bricks are given in the Table I. Each produced test set consists of a triplet of perforated brick blocks with three identical specimens (Fig. 1). Moreover, there are three sets of triplet specimens of which two of them were strengthened by using seismic fabric and its special plaster. The remaining one set of non-strengthening

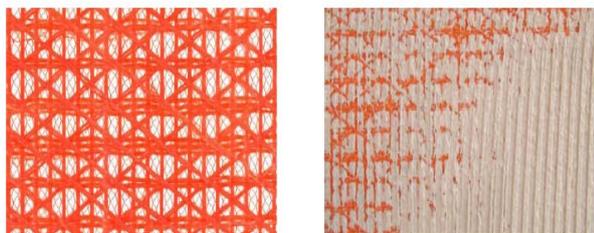
Fig. 2 The hybrid multi-axial seismic textile

The plaster and seismic fabric are implemented in two forms: Unilateral (D1G03) and bilateral (D1G04-T). Additionally, the thickness of plaster layer is equal to 2 cm for D1G03 and 1 cm (on each surface) for D1G04-T. The strengthening process is a combination of multi-axis hybrid seismic textile and special adhesive plaster (Fig. 2). This textile material comprises of alkali-resistant glass and polypropylene fibers.

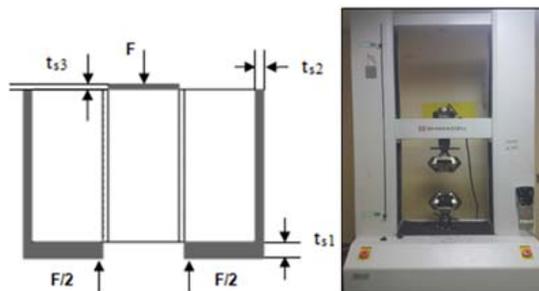
Fig. 3 Scheme of triplet shear test and test device

In this study, all experimental tests were executed at the structural mechanics laboratory of Sakarya University. A vertical load-controlled cylinder having force capacity of 50 kN and loading rate of 1.5 mm/min. was applied perpendicularly to the triplet specimens to investigate the failure behavior of the two mortar joints under shear stress. Triplet shear tests were conducted on perforated brick blocks with and without seismic retrofitting.

A steel plate with a thickness of 12 mm was situated on the middle brick of the triplet specimen in order to reduce the influence of the bending moment and transmit the load properly to the mortar. For providing the stability of the test setup, the outer two bricks were also supported by two steel L profiles. The results of the experimental study are recorded by a displacement sensor integrated into the load cylinder.

Test device in which all experiments conducted and the scheme of triplet test are illustrated in Fig. 3. The relevant thickness parameters (t_s) used in the triplet shear test are $t_{s1}=30$ mm, $t_{s2}=12$ mm and $t_{s3}=12$ mm, respectively.

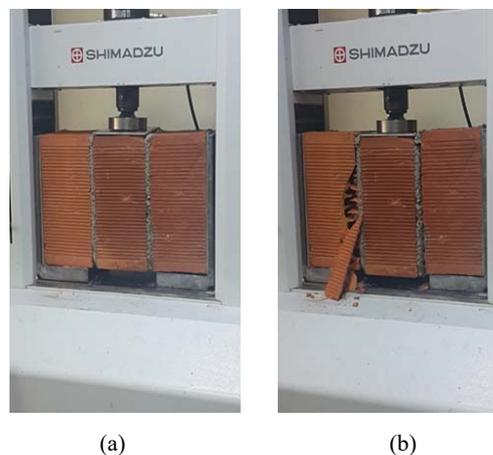
Fig. 4 (a) Initial state and (b) final state of D1R00-1

Firstly, the shear capacity was investigated without applying any plaster which was defined as the reference sample of the non-retrofitted masonry specimen. To describe this case, the non-strengthened control specimens are called as D1R00. Due to the fact that there are three specimens for each experiment set, each sample in the set is designated as D1R00-1, D1R00-2, and D1R00-3, respectively. Both initial and final states of failure under triplet shear test for D1R00-1 are given in Fig. 4.

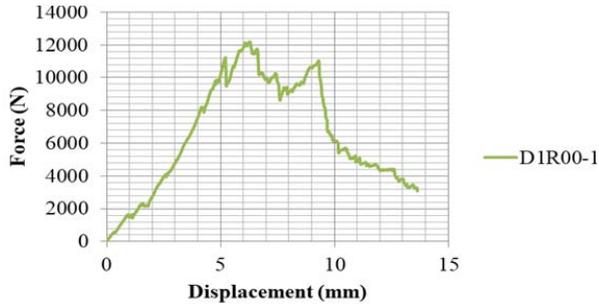
Fig. 5 Force-displacement diagram of the D1R00-1

The maximum shear force F_{max} for this sample is obtained as 12200 N. The attained force-displacement relationship is illustrated in Fig. 5.

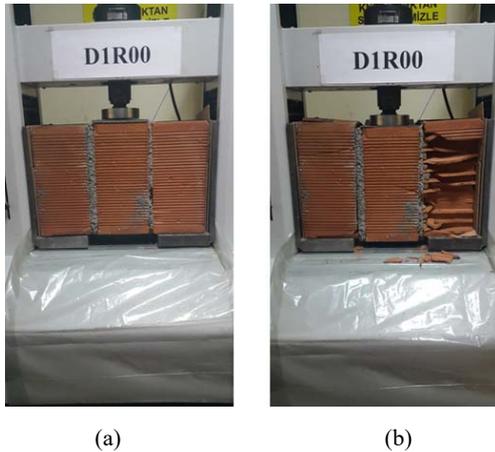
Fig. 6 (a) Initial state and (b) final state of D1R00-2

Similarly, triplet shear tests were performed for the D1R00-2 and D1R00-3 and the resulting crack forms are shown in Figs. 6 and 8, respectively.

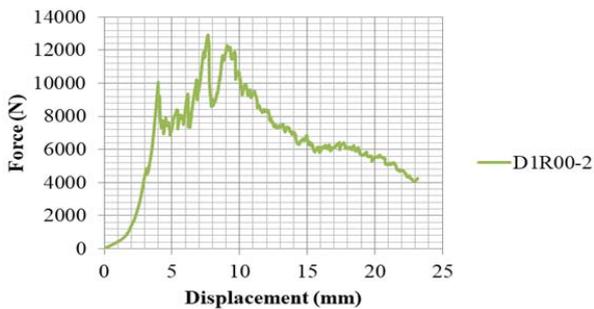
Fig. 7 Force-displacement diagram of the D1R00-2

As can be seen from Figs. 7 and 9, due to lack of ductility, the shear strength of the brick units suddenly decreased and brittle fractures occurred rapidly under stress. These damages are abrupt. The failure surface of specimen exhibits little degradation before the fracture occurs.

In this case, the shear strength, f_v are calculated as 0.117 MPa and 0.138 MPa by considering the experimentally

obtained maximum force of 12920 N and 15316 N, respectively.

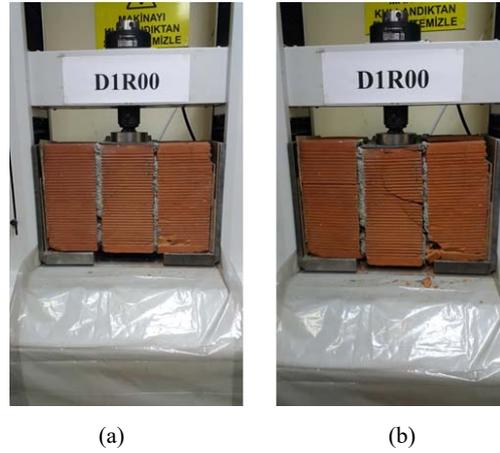
Fig. 8 (a) Initial state and (b) final state of D1R00-3

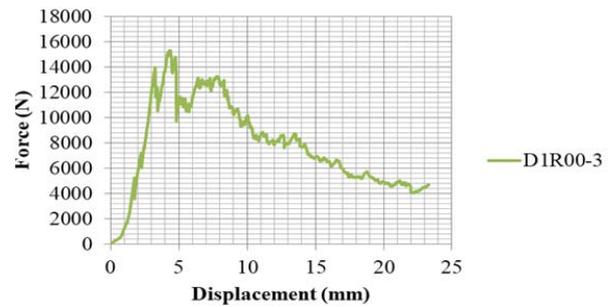
Fig. 9 Force-displacement diagram of the D1R00-3

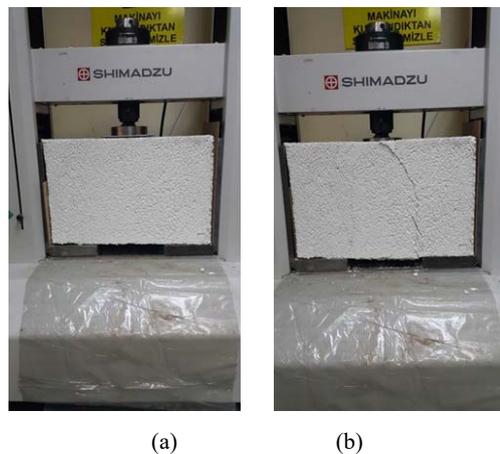
Fig. 10 (a) Initial state and (b) final state of D1G03-1

In the second stage of the experimental study, the effect of the applied seismic textile and the plaster made of expanded glass granular on the shear capacity of mortar joints was investigated. Hereby, the one-sided retrofitted brick specimen with 20 mm reinforcing layer is named as D1G03 for triplet shear test. Firstly, D1G03-1 was tested. The crack pattern of this specimen can be seen in Fig. 10.

The first cracks on the specimens under shear forces were

experienced in vertical form and occurred in brick-mortar interface. When the imposed load reached close to the shear strength capacity of the specimen, the crack widths increased and the middle block separated from the joint plane.

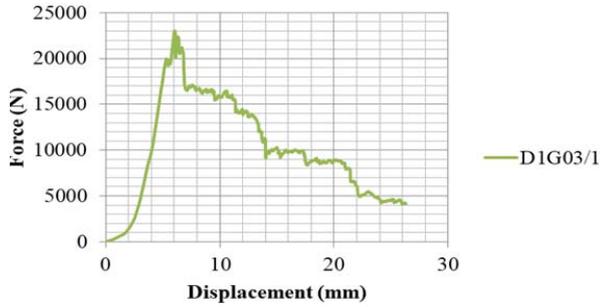
Fig. 11 Force-displacement diagram of the D1G03-1

As shown in Fig. 11, the maximum shear force F_{max} is obtained as 23033 N and the corresponding shear stress value f_v is calculated as 0.209 MPa for specimen of D1G03-1.

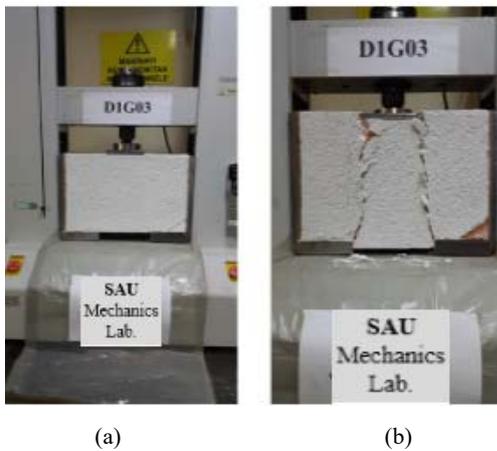
Fig. 12 (a) Initial state and (b) final state of D1G03-2

For the D1G03-2 and D1G03-3 specimens; crack patterns, maximum shear loads and strength parameters were similarly determined. The failure mechanism of the test specimens under the vertical load is shown in Figs. 12 and 14. The maximum shear forces of the second and third sample of the D1G03 test set are equal to 24548 N and 29427 N, respectively (Figs. 13 and 15).

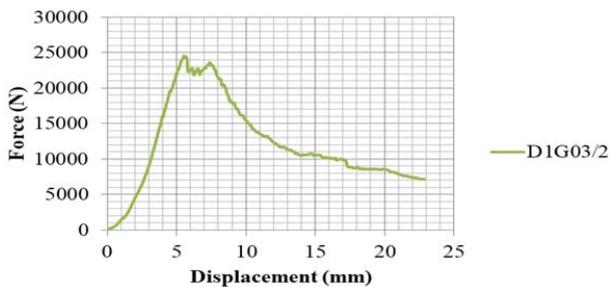
Fig. 13 Force-displacement diagram of the D1G03-2

The values of f_v are 0.220 MPa and 0.267 MPa for D1G03-2

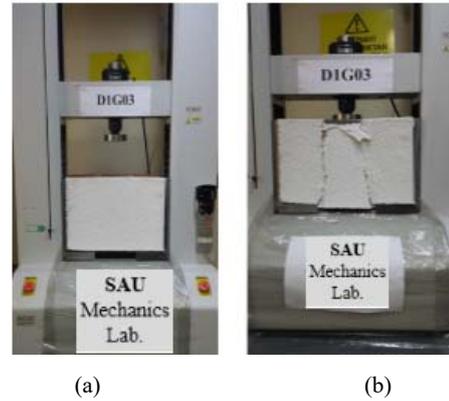
Fig. 14 (a) Initial state and (b) final state of D1G03-3

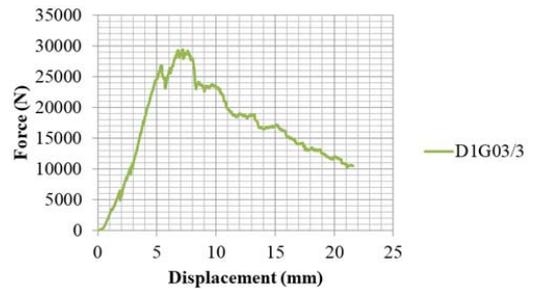
Fig. 15 Force-displacement diagram of the D1G03-3

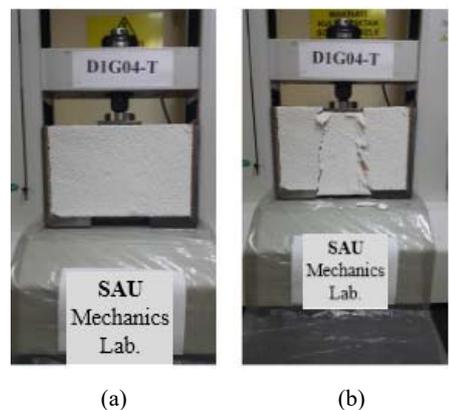
Fig. 16 (a) Initial state and (b) final state of D1G04-T/1

In the final phase of the study, the above mentioned strengthening system was applied to both surfaces of the three specimens and the results were analyzed comparatively. The thickness of the plaster on each surface was considered as 1 cm. The experiment set was named as D1G04-T. Initial and final states of D1G04-T/1 under shear force were in Fig. 16.

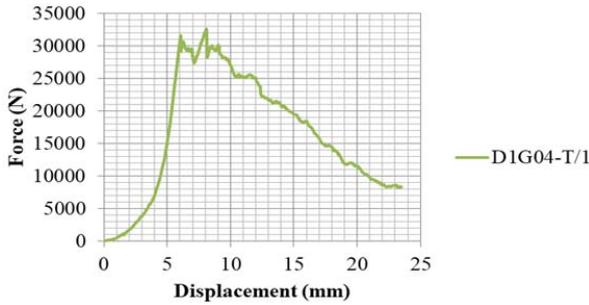
Fig. 17 Force-displacement diagram of the D1G04-T/1

and D1G03-3, respectively. Single-sided retrofitted triplets exhibited more ductile behavior when compared to the reference samples. Furthermore, it was clearly observed that the unilateral strengthening application significantly increased the shear capacity of the masonry building units. The measured value of F_{max} is 32611 N for this case. Also, f_v is calculated as 0.296 MPa. The curve of force-displacement relationship for D1G04-T/1 is depicted in Fig. 17.

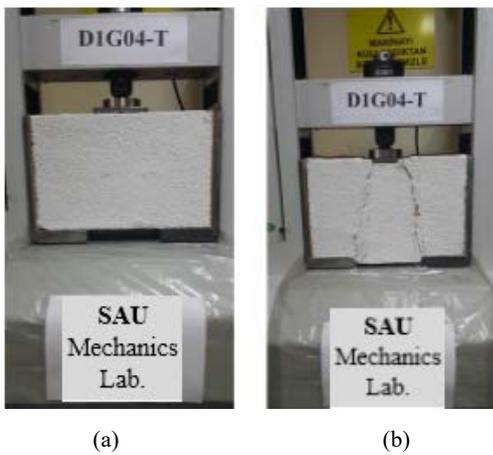
Fig. 18 (a) Initial state and (b) final state of D1G04-T/2

The second and third specimens of the D1G04-T set were also tested. At all specimens in this experiment group, it was obviously seen that the damage started in a similar way to the D1G03 set (Fig. 18).

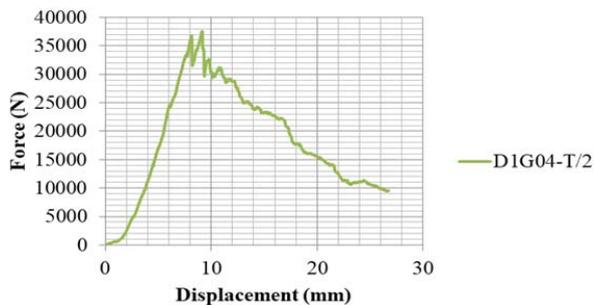
Fig. 19 Force-displacement diagram of the D1G04-T/2

The F_{max} values were determined for these specimens as 37544 N and 36394 N, respectively. The shear strengths were calculated as 0.340 MPa and 0.330 MPa, respectively. The experimental shear force-displacement curve for D1G04-T/2 and D1G04-T/3 are illustrated in Figs. 19 and 21.

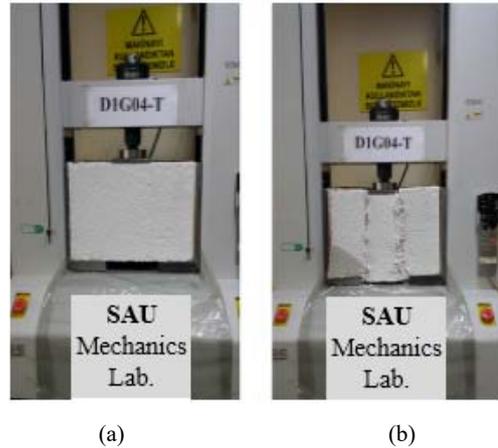
Fig. 20 (a) Initial state and (b) final state of D1G04-T/3

The failure modes of all plastered specimens were similar due to vertical cracks in the direction of loading, which followed the interface between the bricks and joint mortar (Fig. 20).

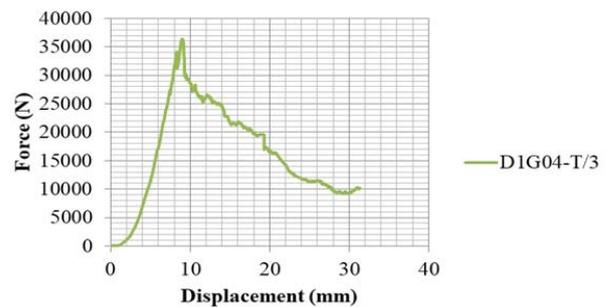
Fig. 21 Force-displacement diagram of the D1G04-T/3

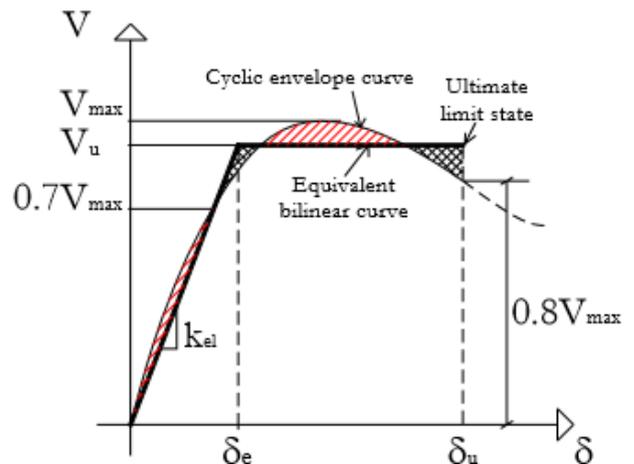
Fig. 22 Bilinear Idealization

Magenes and Morandi [11] calculated the ductility coefficients by idealizing the envelope curve obtained from the experiment with equivalent bilinear curves (Fig. 22). In a similar way, the energy-dissipation capacities of the samples were determined (3), with the force-displacement curves being idealized in this research.

$$\mu = \frac{\delta_u}{\delta_e} \quad (3)$$

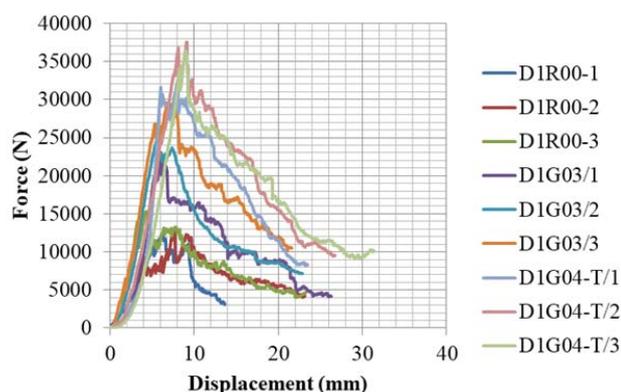
Fig. 23 Comparison of force-displacement diagrams

It is easy to see from the obtained ductility coefficients in Table III, D1G04-T coded samples exhibit a more ductile behavior compared to the other set of experiments (D1G03) and reference samples are insufficient in terms of load bearing capacity, shear strength and energy dissipation. The results of all triplet shear tests performed were compared in Fig. 23.
