# Damage Assessment and Repair for Older Brick Buildings

Tim D. Sass

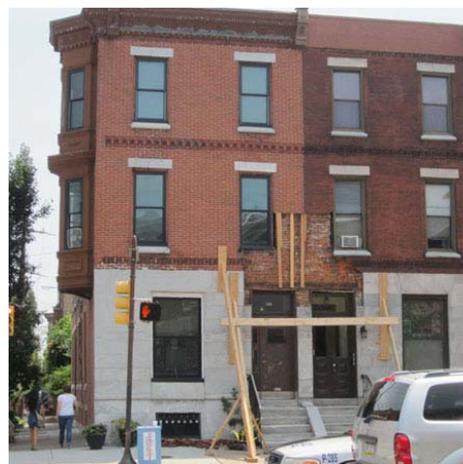
Fig. 1 Brick wall damage

When a brick wall suddenly collapses, the immediate cause is unknown. The collapse could be attributed to the weather or vibrations from nearby construction. A structural engineer called on to investigate many such collapses will learn to include an evaluation of the original construction as part of the forensic study.

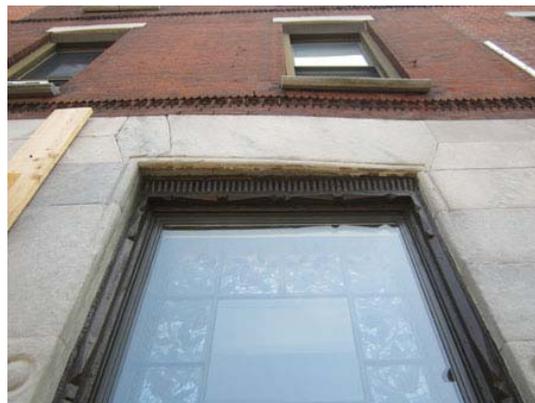
Structural brick walls often bulge around door and window openings. As brickwork bulges, gaps open up around windows and doors. These gaps are typically not uniform and taper down following the bulging brick. Over the years, patch repairs to the building will often include filling gaps in between the door and window openings and the bulging brick with mortar or caulk. Evidence of such previous repairs often remain even on collapsed brickwork and can be used to help determine whether a brick façade was bulging when it collapsed.

Fig. 3 Bulge at window opening
