Wear Behavior of Commercial Aluminium Engine Block and Piston under Dry Sliding Condition

M. S. Kaiser, Swagata Dutta

Abstract—In the present work, the effect of load and sliding distance on the performance tribology of commercially used aluminium-silicon engine block and piston was evaluated at ambient conditions with humidity of 80% under dry sliding conditions using a pin-on-disc with two different loads of 5N and 20N yielding applied pressure of 0.30MPa and 1.4MPa, respectively, at sliding velocity of 0.29ms^{-1} and with varying sliding distance ranging from 260m-4200m. Factors and conditions that had significant effect were identified. The results showed that the load and the sliding distance affect the wear rate of the alloys and the wear rate increased with increasing load for both the alloys. Wear rate also increases almost linearly at low loads and increase to a maximum then attain a plateau with increasing sliding distance. For both applied loads the piston alloy showed the better performance due to higher Ni and Mg content. The worn surface and wear debris was characterized by optical microscope, SEM and EDX analyzer. The worn surface was characterized by surface with

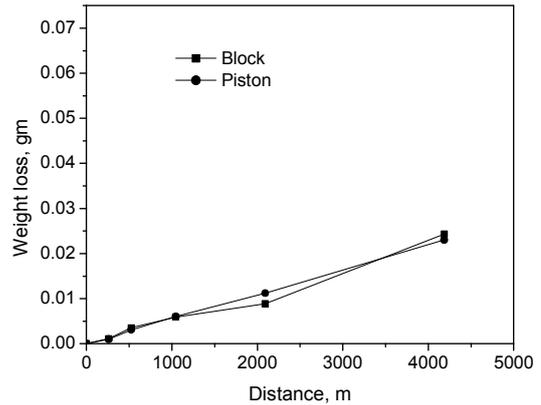
Fig. 1 Variation of weight loss (gm) with the variation of sliding distance (m) at applied pressure of 0.30MPa (Load 5N) and sliding velocity 0.29 ms^{-1}

Figs. 1 and 2 elucidate the variation of weight loss with the variation of sliding speed for both engine block and piston alloy at applied pressure of 0.30MPa (Normal Load 5N) and 1.4MPa (Normal Load 20N) respectively. Moreover, Figs. 3 and 4 depict the variation of wear rate with the variation of sliding speed for both engine block and piston alloy at applied pressure of 0.30MPa (Normal Load 5N) and 1.4MPa (Normal Load 20N) respectively. Other parameters, such as sliding velocity (0.29 ms^{-1}), surface roughness ($2 \mu\text{m}$), and humidity (80%) are identical for these four figures. It can be seen from Fig. 1 that, at lower applied pressure (0.30MPa) the weight loss at all sliding distances vary insignificantly for both block and piston. As the sliding distance increase the weight loss increases for both the alloys. At relatively higher applied pressure (1.4MPa) both the alloys show higher weight loss as compared to weight loss at low load and at all sliding distances (Fig. 2). However, for higher applied pressure, differences in weight loss values for block and piston are evident. The block showed higher weight loss at relatively low and high ends of sliding distance.

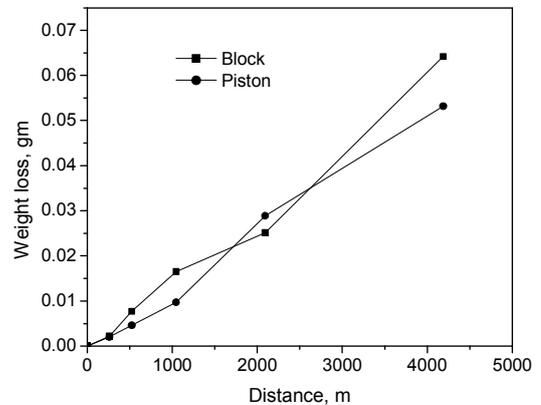
Fig. 2 Variation of weight loss (gm) with the variation of sliding distance (m) at applied pressure of 1.4 MPa (Load 20N) and sliding velocity 0.29 ms^{-1}

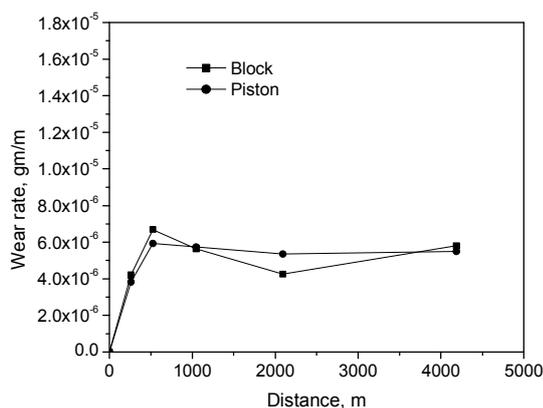
Fig. 3 Variation of wear rate (gm/m) with the variation of sliding distance (m) at applied pressure of 0.30 MPa (Load 5N) and sliding velocity 0.29 ms⁻¹

Figs. 3 and 4 present the wear rate vs. sliding distance plot for both block and piston. At lower applied pressure, it can be observed that wear rate increased at a steep rate initially for both block and piston and after a certain point onwards attained a constant value (Fig. 3). In the case of higher applied pressure, the nature of the curves are quite similar to that of the lower applied load, only difference is in the value of wear rate increased quite significantly for both the alloys (Fig. 4) with block showing higher values than piston at lower and higher realm of the investigated sliding distance range. The competition of frictional heat softening and strain hardening determined the down -and-up trend. Figs. 3 and 4 clearly indicate that the wear rates of both the alloy increased with increasing the load from 5N to 20N. The wear rate for engine block increased from $6 \times 10^{-10} \text{ gm/m}$ (5N) to 1.6×10^{-5} (20N) at sliding distance of 1000 m. For all sliding distances, the wear rate for both the alloys increased one order of magnitude with increasing load from 5N to 20N. For both applied pressures the piston alloy showed lower wear rate as compared to that of block alloy. The result is due to the presence of higher percent of Ni and Mg in piston alloy as seen from the chemical analysis (Table I). Ni forms an intermetallic Al_3Ni which

increases as Ni content increases. This intermetallic increases the strength of the piston alloy leading to lower wear rate. More over Mg addition is beneficial to enhance the abrasion resistance of the alloy due to uniformly distribution of hard particles and reduction of friction coefficient [10]. The sliding movement occurs in very small areas at the peaks and over time. The ruptures or breaks at the peaks increase the contact area and results in rise in temperature. The increase in the load causes rise in friction.

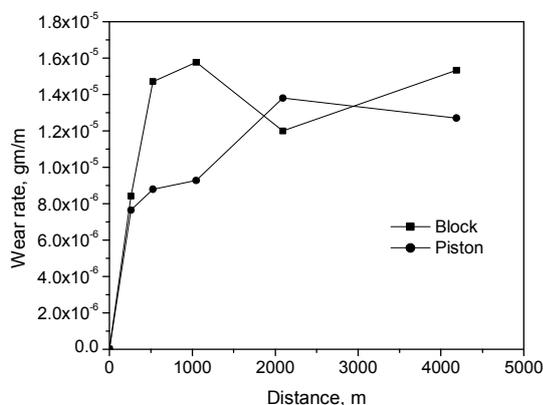
Fig. 4 Variation of wear rate (gm/m) with the variation of sliding distance (m) at applied pressure of 1.4 MPa (Load 20N) and sliding velocity 0.29 ms⁻¹

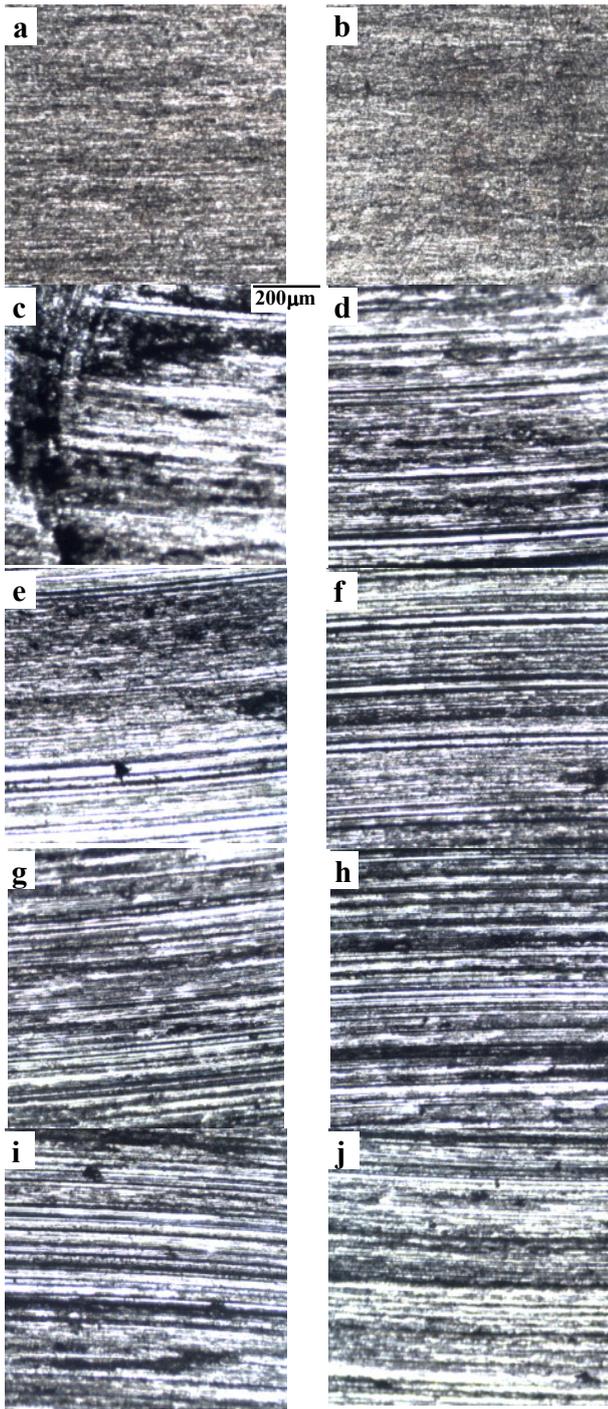
Fig. 5 Optical micrograph of worn surfaces before wear (a) block, (b) piston, after wear at applied pressure of 0.30MPa for 15 min (c) block, (d) piston, for 4 hours (e) block, (f) piston, at applied pressure of 1.40MPa for 15 min (g) block, (h) piston and for 4 hours (i) block (j) piston

In this study of dry sliding wear of two Al-Si alloys against a cast iron counter-body, the wear was described as a mixed mode of elastic-plastic contact where Archard's law was obeyed. The applied pressure range investigated was 0.30 MPa and 1.4 MPa. This range of applied pressure was previously found to exhibit mild wear (MW) in these alloys [11]. In Fig. 5 are presented the worn surfaces for both block and piston alloys at different loads and sliding distances. Firstly, it can be observed that for a given alloy and for a given load, as the sliding distance increase the wear marks becomes more visible and deep. In some portions of the investigated worn surface there are evidence of crater formation. It can also be seen that for a given alloy and at a given sliding distance, as the load is increased the wear marks also becomes more deep and prominent. Increasing the load from 5N to 20N also increases the fraction of flaky wear debris. At low loads and at all sliding distances, the wear marks in the worn surfaces of block and piston alloy are similar in nature whereas at higher applied loads the wear marks in the worn surfaces of block are more deep and intense than that of the piston alloy leading to their higher material loss and corresponding high wear rate. The wear mechanisms in the dry sliding of Al-Si alloys can be classified as oxidative wear. Oxidative wear occurred at low applied loads. In this wear process an aluminium oxide layer (10-80 pm) formed on both the wearing Al-Si surface and the counter-face [11]. Wear occurred firstly by oxidation of the asperities and then secondly by fracture and compaction of the oxidized wear debris into this film. The wear rate was low, due to the amount of metal removed being confined to the thickness of this oxide formation. Some localized deformation of the substrate and fracture of the Si particles was observed. Oxidative wear was considered to be generally independent of the Si content or Si particle size. Under conditions of mild wear a tribolayer was formed on the surface of Al-Si alloys. This layer was found to consist of an ultrafine mixture of aluminium, silicon and α -iron. The formation of this surface resulted from the transfer of material from both the Al-Si alloy pin material and the steel counter-face. It was also found that the observed iron-rich layer, formed on the Al-Si surface due to mutual material transfer between the sliding surfaces, was composed of an ultrafine mixture of Al, Si and α -Fe (<1 μ m). Furthermore, it was argued that as wear continued, the deposition reached a stage where these transferred layers could not adhere and became detached [11].

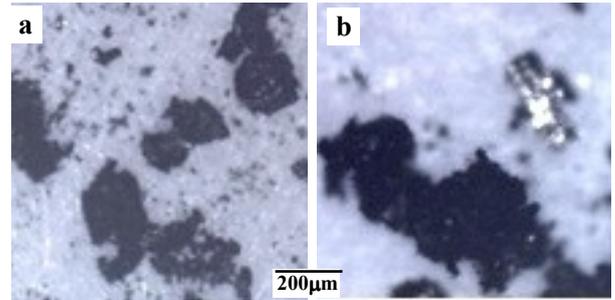
Fig. 6 Wear debris collected from wear test at 1.4 MPa (20N) applied pressure and sliding distance of 4200m for (a) Block, (b) Piston

Fig. 6 shows the typical wear debris collected from the wear test. At low loads the wear debris was equiaxed, laminar and consisted of a small iron content. An increase in the applied normal load formed wear debris of various shapes and sizes. The debris size ranged from a few microns, to a few millimeters. Visually, the debris produced at 20 N appeared in

the form of a dark, brown powder. The micrograph (Fig. 6) shows the debris produced at a load of 20 N was mainly composed of very fine, equiaxed particles but also contained plate-like and ribbon-shaped iron particles in smaller amounts. The fine and large debris particles were a mixture of Al, Si, Fe, and oxygen. The ribbon-shaped particles had an appearance similar to machined chips, and were mainly composed of Fe indicating that they were cut from the steel counter-face.

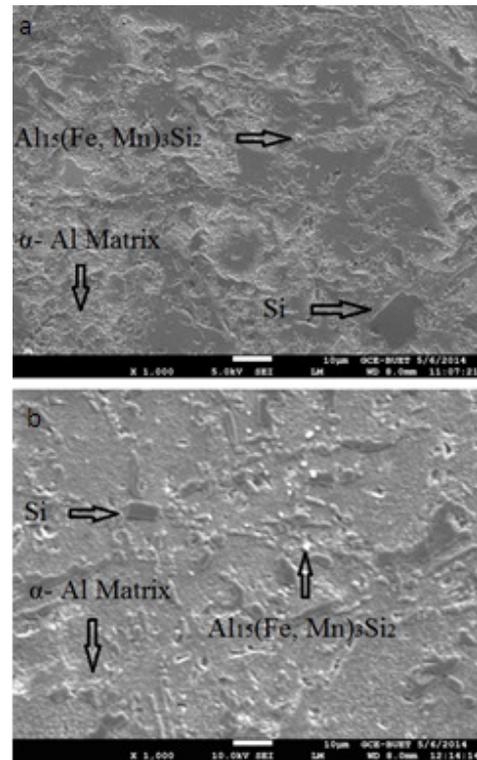
Fig. 7 SEM micrographs of as-received Al-Si (a) block and (b) piston

The SEM micrographs of as-received Al-Si block and piston are shown in Figs. 7 (a) and (b) respectively.

The microstructure consisted of mainly primary Al dendrite, eutectic Si, $Al_{15}(Fe, Mn)_3Si_2$, Mg_2Si and a few number of Fe-rich intermetallic phases on α -Al matrix in the inter-dendritic region. It can be seen that the eutectic Si phase is flake-like

and acicular morphologies. Two type of NiAl_3 phase are the plate-like and needlelike morphologies [7].

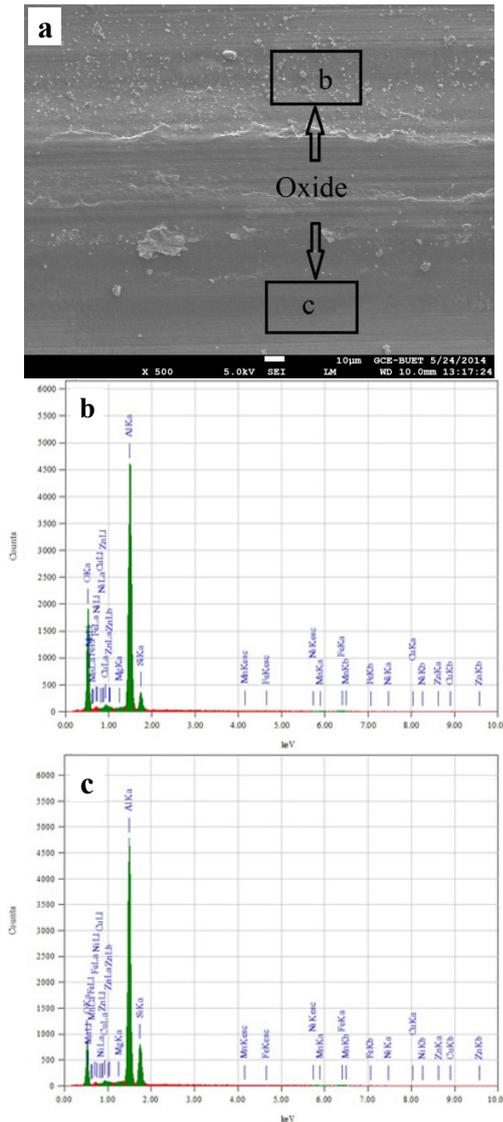
Fig. 8 SEM images of worn surfaces of aluminium engine block after wear at 1.4 MPa applied pressure and sliding distance of 4200m

The SEM micrographs of the worn surfaces of Al-Si block and piston are shown in Figs. 8 and 9. The corresponding EDX profile analysis of the block alloy for the selected area of the SEM is shown in Figs. 8 (b) and (c). The weight percentage of elements found by EDX analysis in these areas were 37.67% O, 51.03% Al, 5.60% Si, 0.75% Mn, 3.74% Fe and 0.76% Cu, 0.44% Zn and, 22.23% O, .04% Mg, 58.01% Al, 15.49% Si, 2.27% Fe, 0.72% Ni, 0.80% Cu, 0.42% Zn respectively.

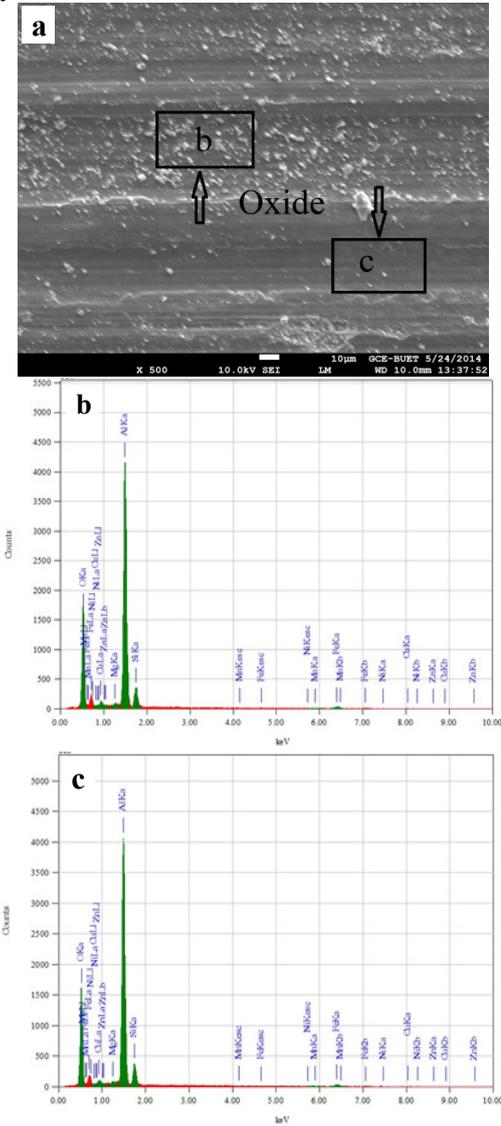
Fig. 9 SEM images of worn surfaces of aluminium engine piston after wear at 1.4 MPa applied pressure and sliding distance of 4200m

The corresponding EDX profile analysis of piston alloy for the selected area of the SEM is shown in Figs. 9 (b) and (c). The weight percentage of elements found in these areas were 33.82% O, 0.12% Mg, 48.00% Al, 5.69% Si, 0.17% Mn, 10.61% Fe, 0.42 Ni, 1.01% Cu, 0.1% Zn and 33.93% O, .15% Mg, 48.45% Al, 5.99% Si, 0.45% Mn, 9.70% Fe, 0.34% Ni,

0.86% Cu, 0.13% Zn respectively. The EDX data clearly reveals the high oxide content in the selected areas which suggest the oxidative wear was the dominant process. In case of block alloy the EDX analysis of the investigated areas reveals that the oxide content is unevenly distributed. Whereas for piston alloy the oxide content is roughly uniform which can be responsible for lower wear rate for the piston alloy. This can be due to the variation of chemical composition of the alloys.
