A Review on Concrete Structures in Fire

S. Iffat, B. Bose

Abstract—Concrete as a construction material is versatile because it displays high degree of fire-resistance. Concrete's inherent ability to combat one of the most devastating disaster that a structure can endure in its lifetime, can be attributed to its constituent materials which make it inert and have relatively poor thermal conductivity. However, concrete structures must be designed for fire effects. Structural components should be able to withstand dead and live loads without undergoing collapse. The properties of high-strength concrete must be weighed against concerns about its fire resistance and susceptibility to spalling at elevated temperatures. In this paper, the causes, effects and some remedy of deterioration in concrete due to fire hazard will be discussed. Some cost effective solutions to produce a fire resistant concrete will be conversed through this paper.

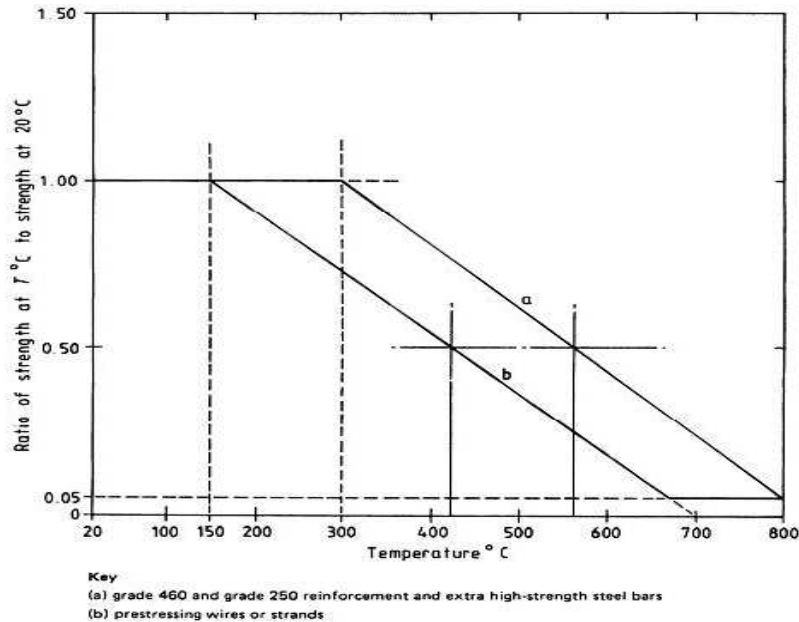
Fig. 2 Variation of steel strength with temperature [20]

in temperature is markedly lesser in high strength steel than a pre-stress wire member (Fig. 2). Steel ratio and strength of concrete have major influences on the fire resistance of the concrete structures under fire [22].

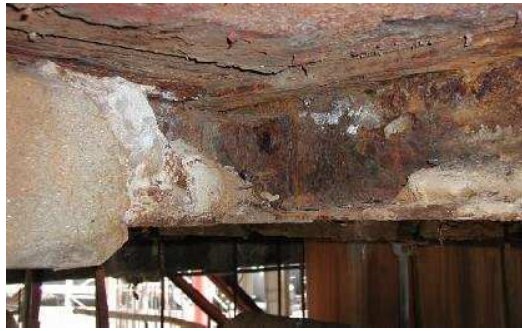
Fig. 4 Crack development in concrete structure due to fire

Geogali & Tsakiridis [31] made a case study of cracking in a concrete building subjected to fire, with particular emphasis on the depths to which cracking penetrates the concrete. It was found that the penetration depth is related to the temperature of the fire, and that generally the cracks extended quite deep into the concrete member. Major damage was confined to the surface in close proximity to the fire origin, but the nature of cracking and discolouration of the concrete pointed to the concrete around the reinforcement reaching 700°C. Cracks which extended more than 30 mm into the depth of the structure were attributed to a short heating/cooling cycle due to the fire being extinguished.

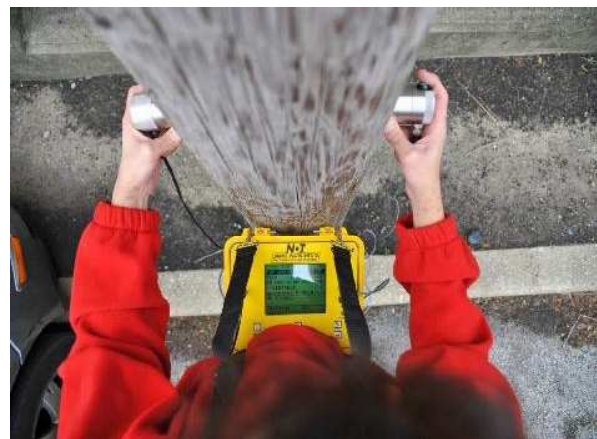
Fig. 6 UPV testing of concrete member

The UPV (Ultrasonic Pulse Velocity) measurement (Fig. 6) is one of the various non-destructive test methods used to evaluate concrete integrity and – more generally – the level of damage in the material. In particular, the velocity of sound in concrete is a high-quality thermal-damage indicator, due to its sensitivity to any change of the Young's modulus. When concrete is exposed to fire, the increase of temperature in the deeper layers of the material is rather slow and progressive. Because of this (due to the rather low thermal diffusivity of concrete), this process produces significant temperature gradients between the outer and inner layers of any given concrete structure (i.e. between the surface and the core). UPV technique may also be applied to determine the reduced quality of concrete by means of indirect or direct techniques on cores [36], [37].

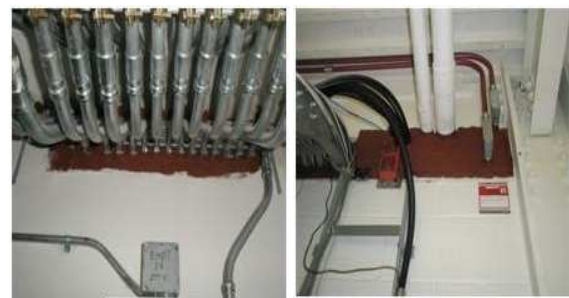
Fig. 9 Fire penetration protection system

Penetrating items are steel, ferrous or copper pipes, tubes or conduits. Annular space between the item and the fire-resistance-rated wall must be filled to maintain the fire-resistance rating with filling material - concrete, grout, or mortar (Fig. 9). Separation in buildings by structural elements prevent horizontal and vertical spread of fire [39]
