# Restoring, Revitalizing and Recovering Brazilian Rivers: Application of the Concept to Small Basins in the City of São Paulo, Brazil

**Abstract**—Watercourses in Brazilian urban areas are constantly being degraded due to the unplanned use of the urban space; however, due to the different contexts of land use and occupation in the river watersheds, different intervention strategies are required to requalify them. When it comes to requalifying watercourses, we can list three main techniques to fulfill this purpose: restoration, revitalization and recovery; each one being indicated for specific contexts of land use and occupation in the basin. In this study, it was demonstrated that the application of these three techniques to three small basins in São Paulo city, listing the aspects involved in each of the contexts and techniques of requalification. For a protected watercourse within a forest park, renaturalization was proposed, where the watercourse is preserved in a state closer to the natural one. For a watercourse in an urban context that still preserves open spaces for its maintenance as a landscape element, an intervention was proposed following the principles of revitalizat

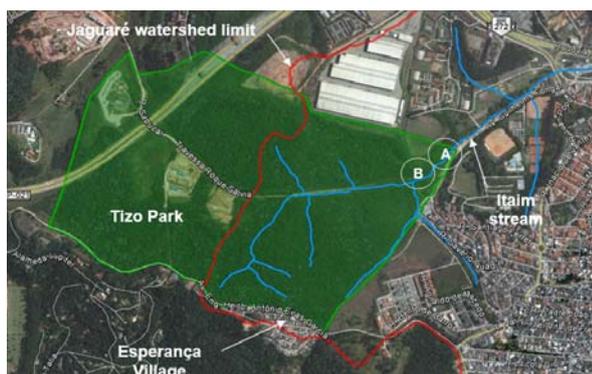
Fig. 2 Location of the Itaim stream in Tizo Park. Source: Prepared by the author from Google Earth Pro

For the application of these steps and elaboration of a restoration proposal, the area of Itaim stream was chosen, a greater tributary of the Jaguaré stream that is inside Tizo Park. Although the springs have been protected since the creation of the park, they are influenced by the pollutant loads coming from the external areas and diffuse loads coming from Esperança Village, which borders the park. Fig. 2 shows the location of the Tizo park area in green and the Itaim stream within the park.

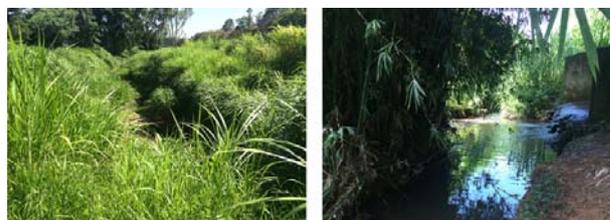
Fig. 3 Itaim stream in Tizo Park. Source: Photos of the author

In addition to the threats due to the release of pollutant loads, the channels within the park are not in totally natural conditions, and not integrated with the park goers. The section near the entrance to the park has its banks taken by tall exotic vegetation, which prevents access and even the view of the channel, as shown in Photo A of Fig. 3. Photo B of the same figure shows a second stretch of the canal where access is possible, but that presents the banks that are eroded and

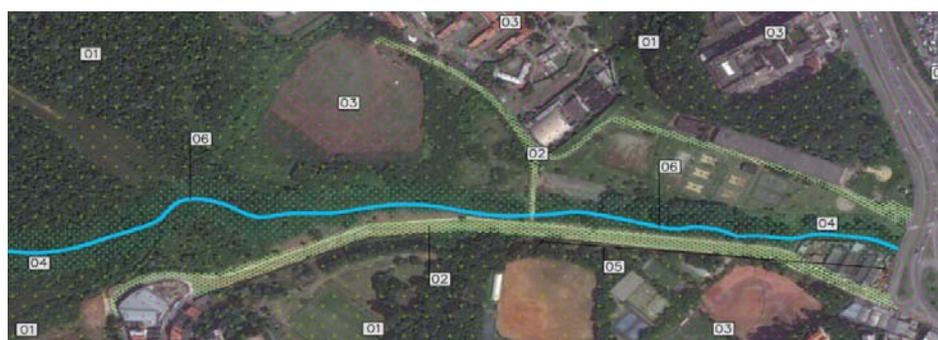
**Legend: (01) Area that demands environmental enrichment; (02) Road that requires green infrastructure; (03) Buildings and facilities; (04) Requalification of the floodplain area; (05) Zone next to the visitation area: demands water observation equipment; (06) Requalification of the channel.**

Fig. 5 Proposal for restoration of Itaim stream in Tizo Park. Source: Prepared by the author

Itaim stream has enormous potential for restoration since it is inserted in a context of vegetal remnant under protection; in this way, a series of measures were proposed for restoration, in order to attend the set of detailed techniques, as presented in the section of Figs. 4 and 5.

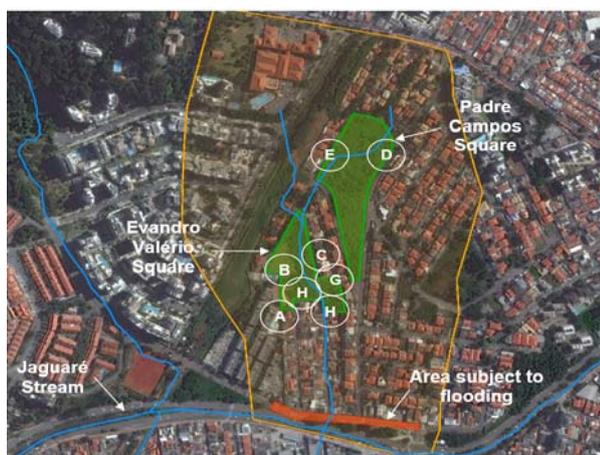
Fig. 6 Location of the Evandro Valério and Padre Campos squares in the Jaguaré watershed. Source: Prepared by the author from Google Earth Pro

The Squares Evandro Valério and Padre Campos, despite having favorable conditions for the maintenance of a watercourse, shelter a stream canalized in an underground gallery. According to the residents of the squares, the stream was canalized in response to requests from the population itself, since it was polluted generating a series of inconveniences, such as the presence of urban pests (insects and rats) and the exhalation of odors from sewage deposited improperly. Fig. 6 shows the contributor basin (Orange), the area of the squares (Green), the location of the watershed, and the location of the photographic memorial. The basin also has an area subject to flooding that can be solved with the implementation of sustainable drainage.

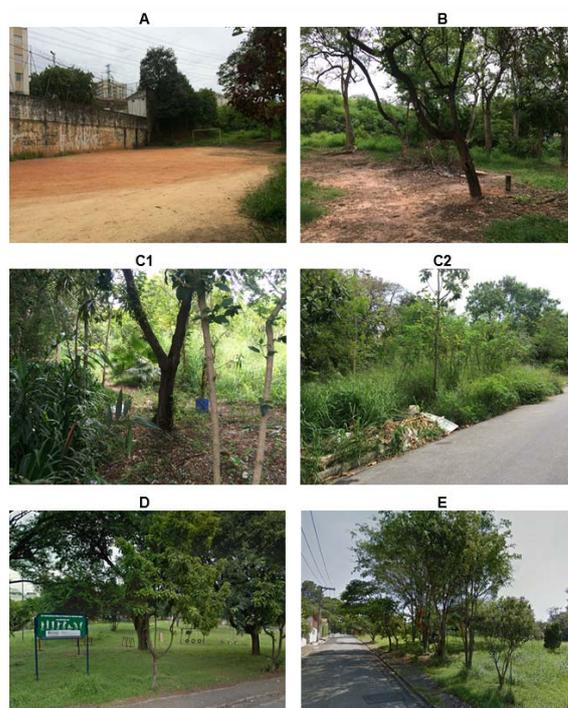
Fig. 7 Evandro Valério Square in the Jaguaré watershed. Source: Photos of the author

Fig. 7 shows emblematic points of the squares. Point A shows a football field installed by the population; photo B, photo C1 and photo E illustrate the density of vegetation at different points; photo C2 shows the lack of maintenance in one of the stretches, where vegetation invades the sidewalk, which ends up encouraging the inadequate deposit of waste by the population; and photo D shows an excerpt that has public equipment for sports practices.

The square also houses a spring that has a contribution from the underground aquifer, since it remains in the landscape with significant flow even in the dry season (Volumetric flow on 08/10/2015 = 0.33L/s), which is used intensively by the population for water abstraction for non-potable uses. In a 30-minute observation period from the source on a Saturday,

eight users were registered visiting the source for water collection (gallons) and car wash. The spring (photo G) was treated by the municipality service through the construction of a gravel trench, according to a resident, who directed the water to a catchment point where the population captures the waters (photo H2).

The square receives the sewage of some houses, which is collected by a concrete box built by the local population (photo H1), it unduly directs the collected sewage to a drainage gallery near the spring. A sewage network exists a few meters from this box, and therefore it would be necessary to promote the correct connection, to eliminate this pollution source (photo H3). The site demands interventions to consolidate the sewage system in order to guarantee the preservation of the spring waters, since the demand for its waters by the population is high and the lack of proper management can pose a serious health risk. Fig. 8 below shows the area situation.

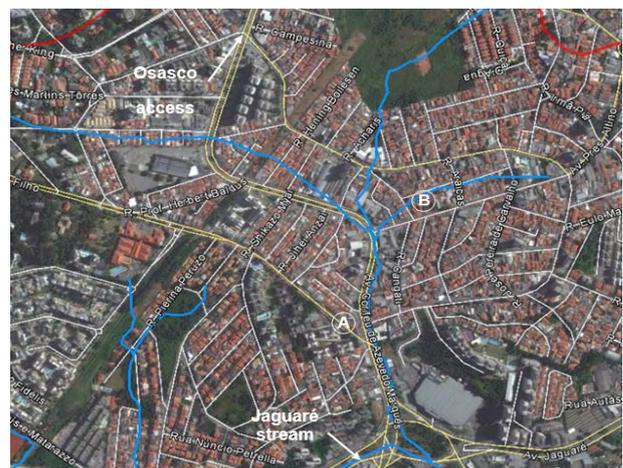
Fig. 10 Location of the canalized stream under Corifeu de Azevedo Marques Av. Source: Prepared by the author from Google Earth Pro

The stream under Av. Corifeu de Azevedo Marques is tributary of the Jaguaré stream, also runs under this avenue and surrounding streets; therefore, it has low potential for revitalization that would include the opening of the underground galleries since the avenue has heavy traffic. The channel opening in Corifeu de Azevedo Marques Avenue would require the complete deconstruction of the avenue, which is an important axis of circulation that connects Butantan village, Osasco city and Mario Covas highway. Today, the avenue has two lanes of road, one lane of buses and a track for cycling in each of the directions. In addition, the tributaries of the watercourse are under the narrow streets, so its opening would make it impossible for vehicles and traffic to travel these routes. The location of the watercourses and the situation of the roads are shown in Fig. 10 and Fig. 11, respectively.

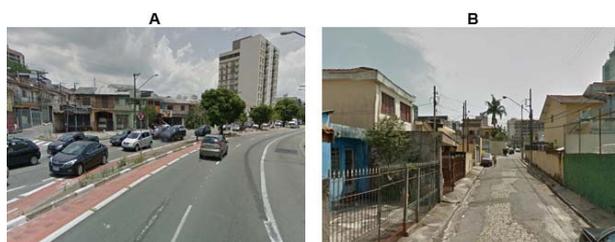
Fig. 11 Stream channeled under Corifeu de Azevedo Marques Avenue in the Jaguaré watershed. Source: Author's Photos
